AFRL-ML-WP-TR-1999-4040

TESTING OF AIRCRAFT RUNWAY ICE CONTROL PRODUCTS

MATERIALS COMPATIBILITY

OCTOBER 1998

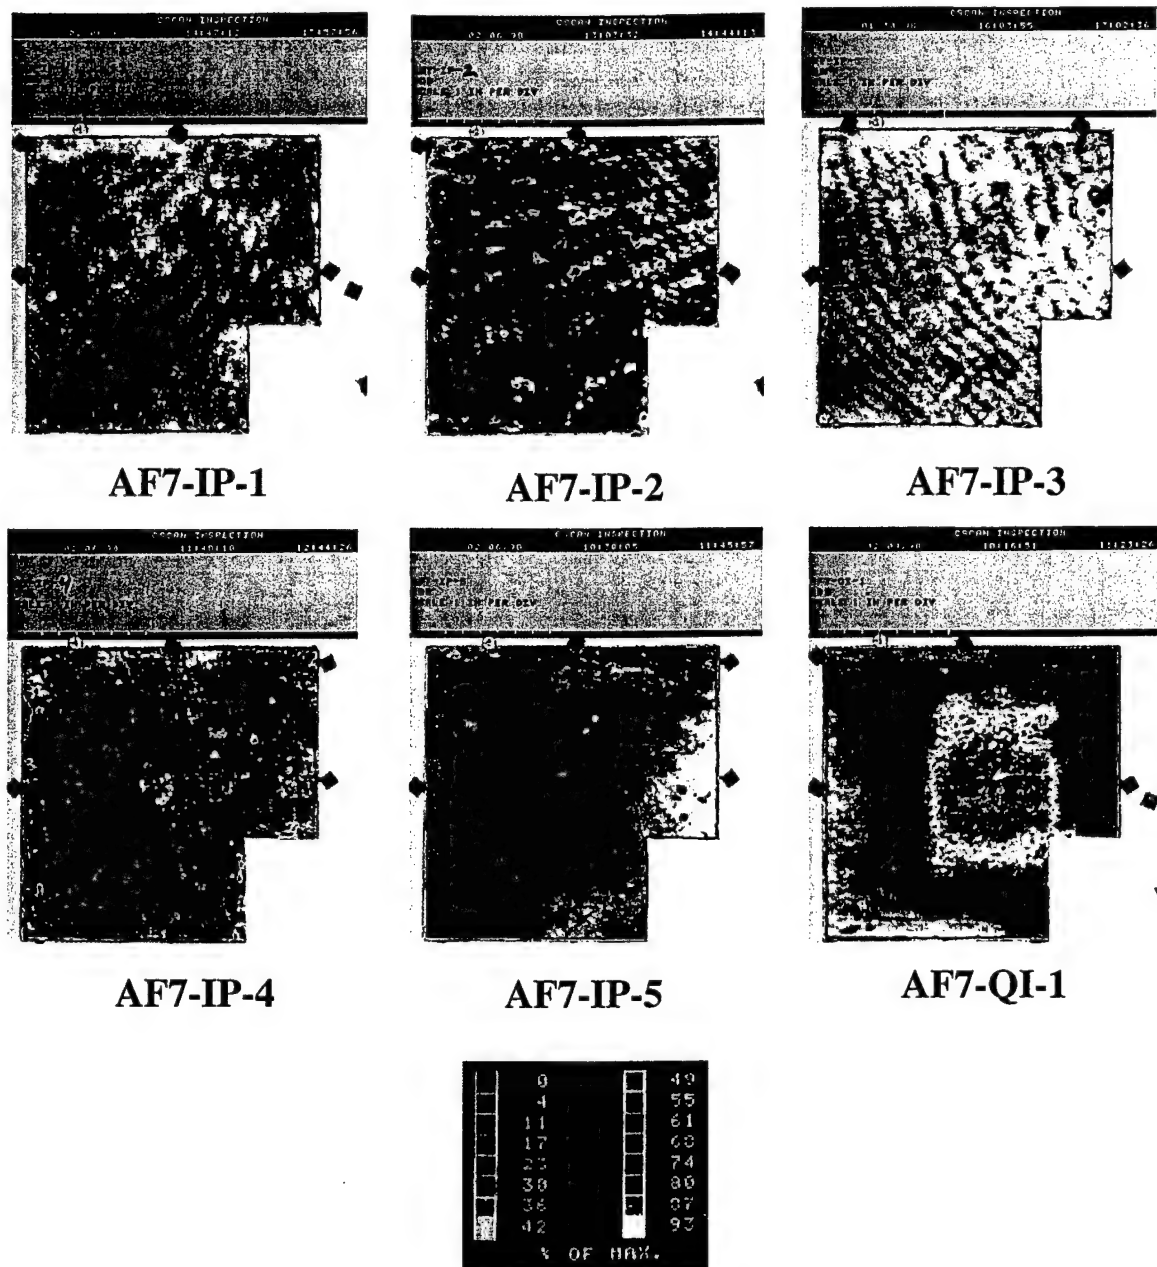
Figure 1. NDE C-scans of the S-2/AFR700B panels. The tag end specimens were removed (bottom right corner) from each panel prior to NDE testing. The loss in signal was attributed to microcracking within the panels.

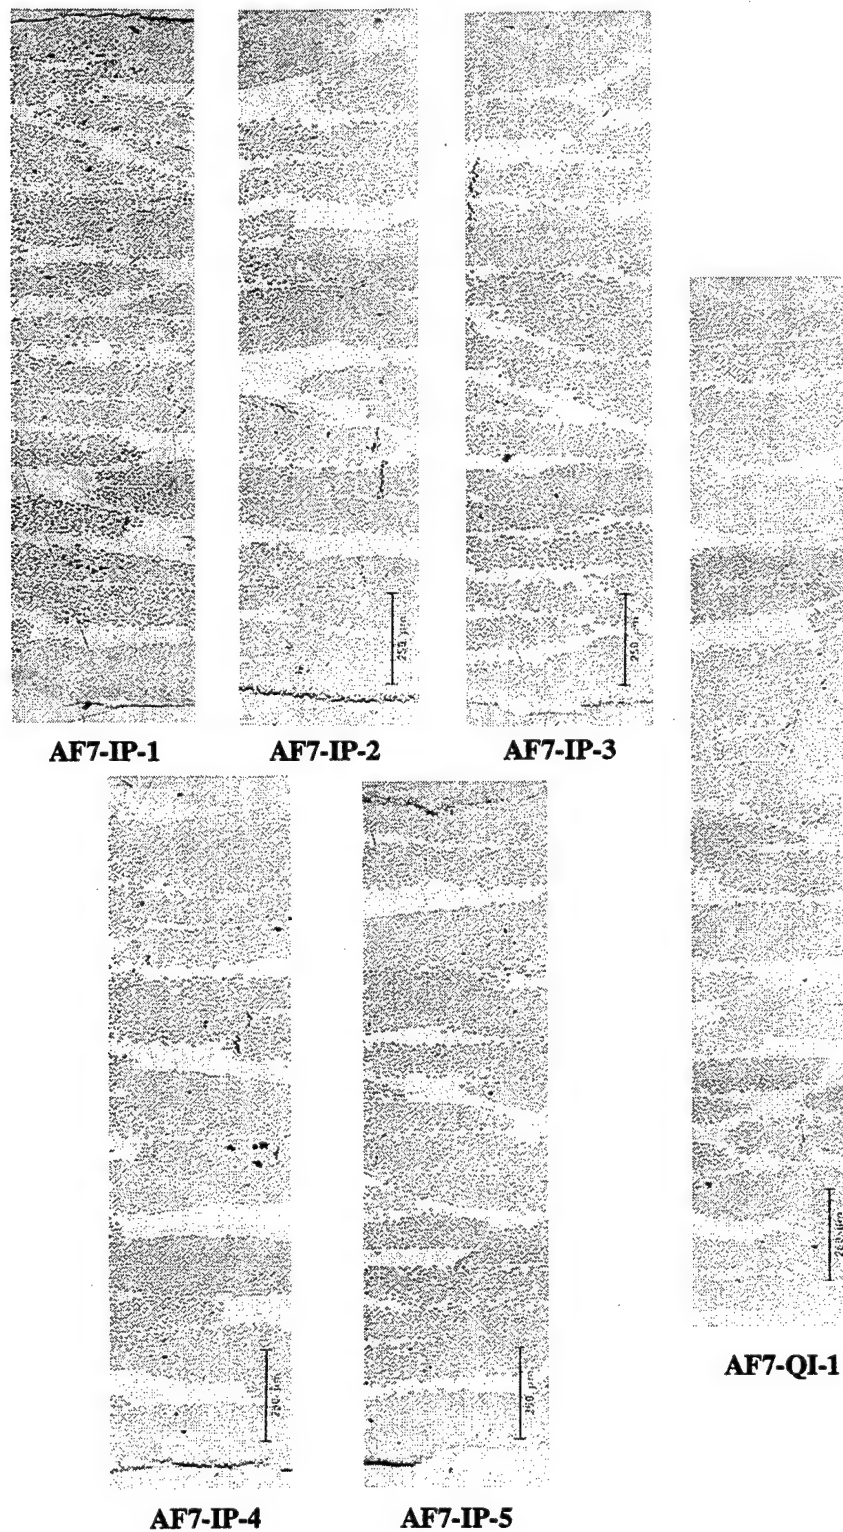
Figure 6. Cross-sectional photomicrographs of the S-2/AFR700 Tag End cross-sections. Small amounts of microcracking were observed. Scale bar in photos equals 250 microns.

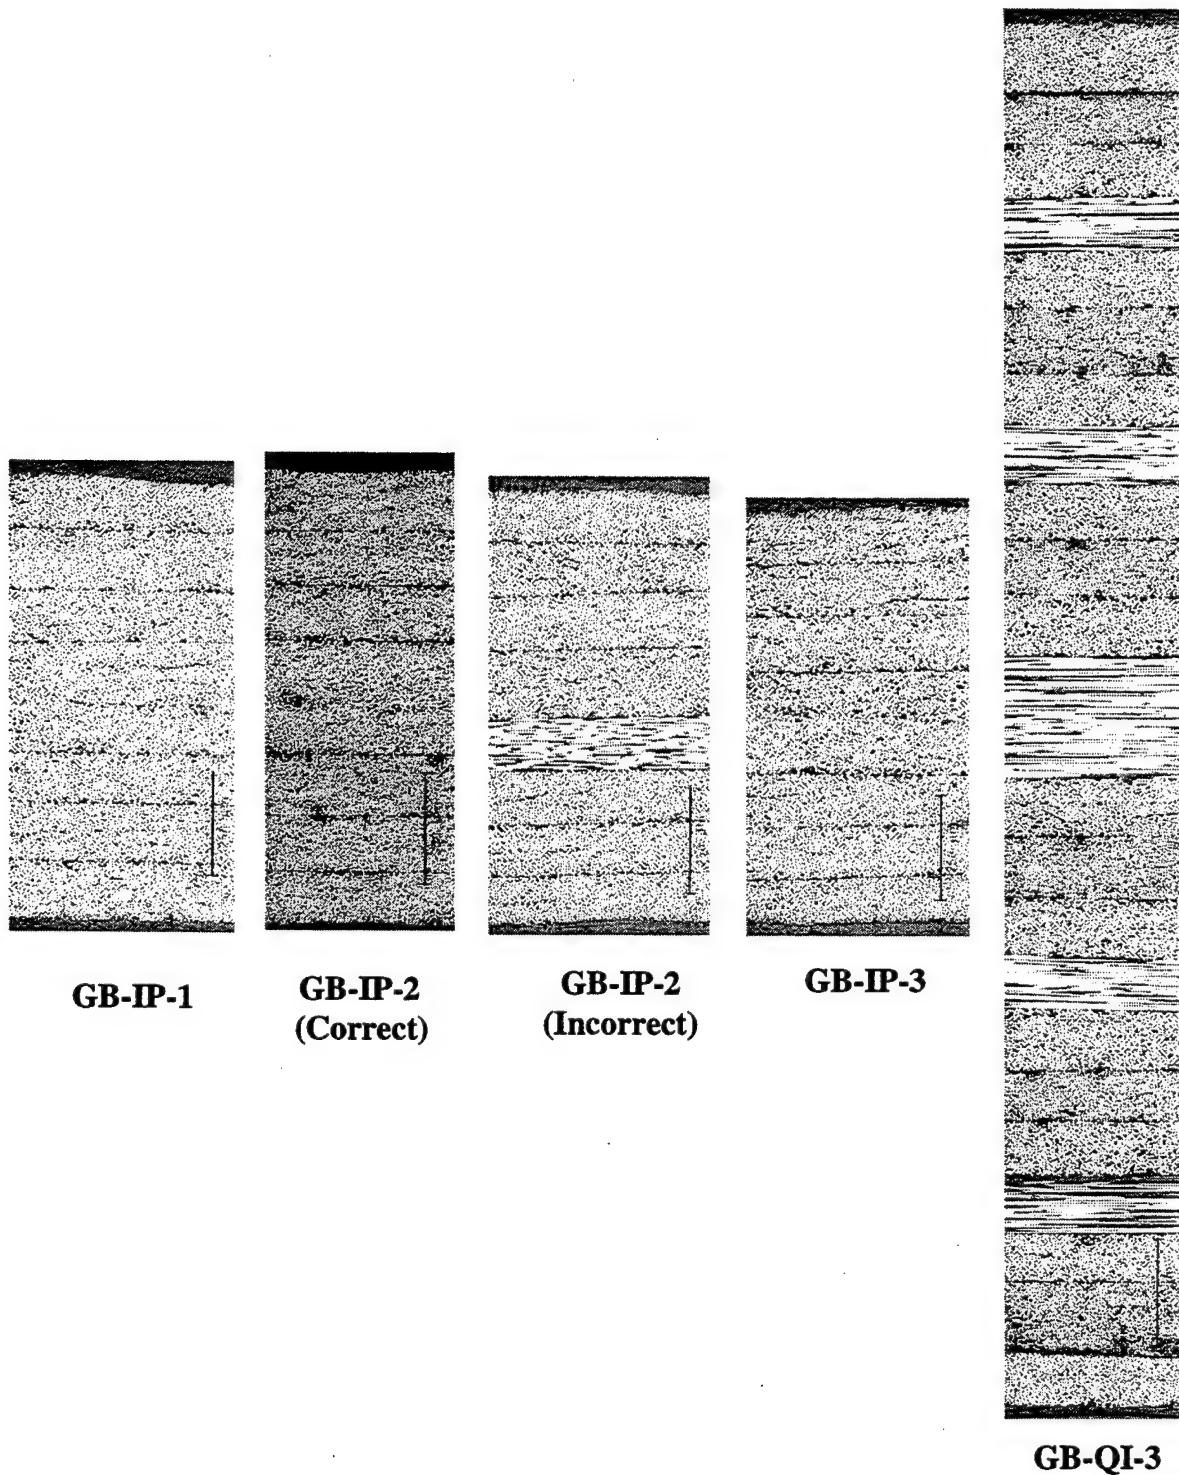
Figure 7. Cross-sectional photomicrographs of the IM7/5250-4 Tag End cross-sections. One half of panel GB-IP-2 contained an incorrect layup while the other half was correct. Scale bar in photos equals 250 microns.

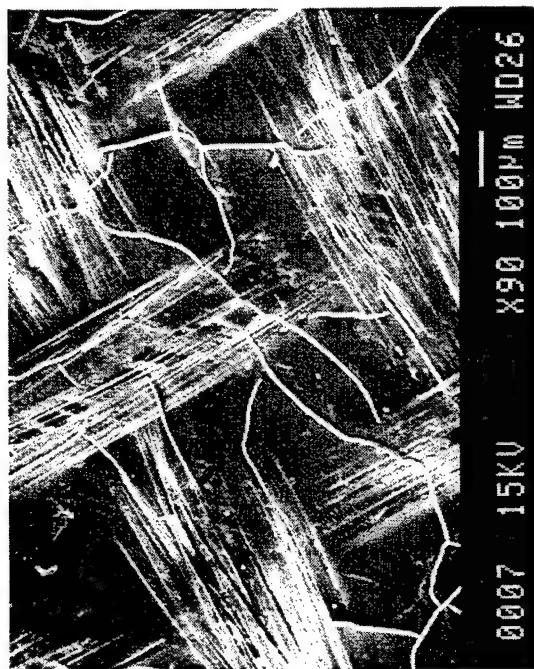
Figure 24. SEM photos of the IM7/5250-4 surfaces (A: tool side; B: bag side) exposed to the UREA deice fluid (sandwich corrosion). Cracking in the outer layer (surface) of the resin was observed.

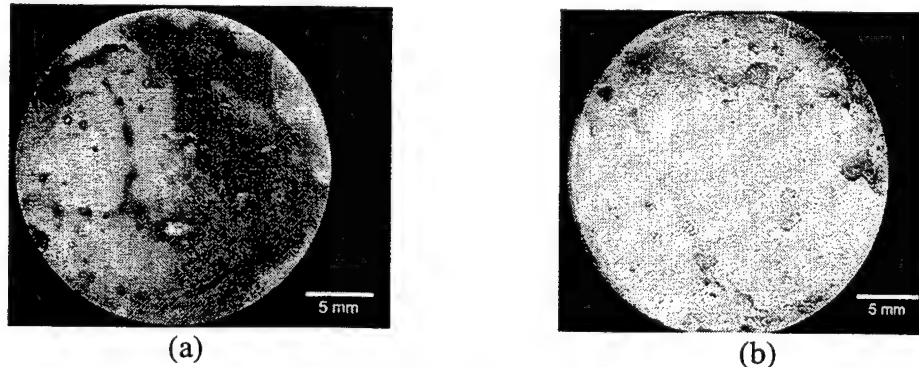
Sodium formate should not be used as a deicer/anti-icer fluid for Air Force systems that use exposed Ge, Poly-Si, or ZnS IR windows. The deicer/anti-icer fluid will stain the window, reduce its transmission and thus the performance of the system. If sodium formate must be used, it is recommended that an additional cleaning study be performed to determine whether or not a solvent exists that will remove the sodium formate stains from these window materials.

Figure 2. Post-test photographs of (a) Ge and (b) ZnSe that were stained by sodium formate.

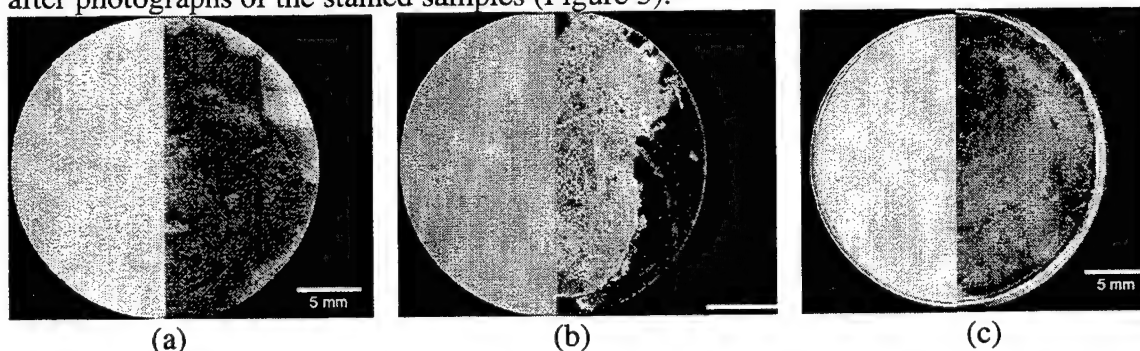
After examining the data in Table 3, it is clear the sodium formate deicer has caused transmission loss in the Ge, Poly-Si and ZnS samples, while the other deicer fluids caused little or no change to the majority of IR window materials tested. The REP/DAR samples suffered some transmission loss because the back side AR coating was attacked by the two acetate deicers. This coating would never be exposed to the flight line environment, and thus would not come in contact with any deicer fluids. In this limited study only the sodium formate negatively affected many of the window materials. Close visual inspection and the digital photographs confirmed this phenomenon. The sodium formate stained many of the samples and the residue left behind is absorbing in the IR. These stains are easily identified by comparing before and after photographs of the stained samples (Figure 3).

Figure 3. Before (left side) and after (right side) composite photographs of (a) Ge, (b) Poly-Si, and (c) REP/DAR ZnS IR window materials after being exposed to sodium formate.

An attempt was made to removed these stains first using water, then acetone and finally with alcohol. None of these basic solvents were able to remove the stains. When the transmission spectrum of each stained sample is closely examined, a small absorption band is found in the 8-11.5 μm region. This band is due to the stain caused by the sodium formate deicer.

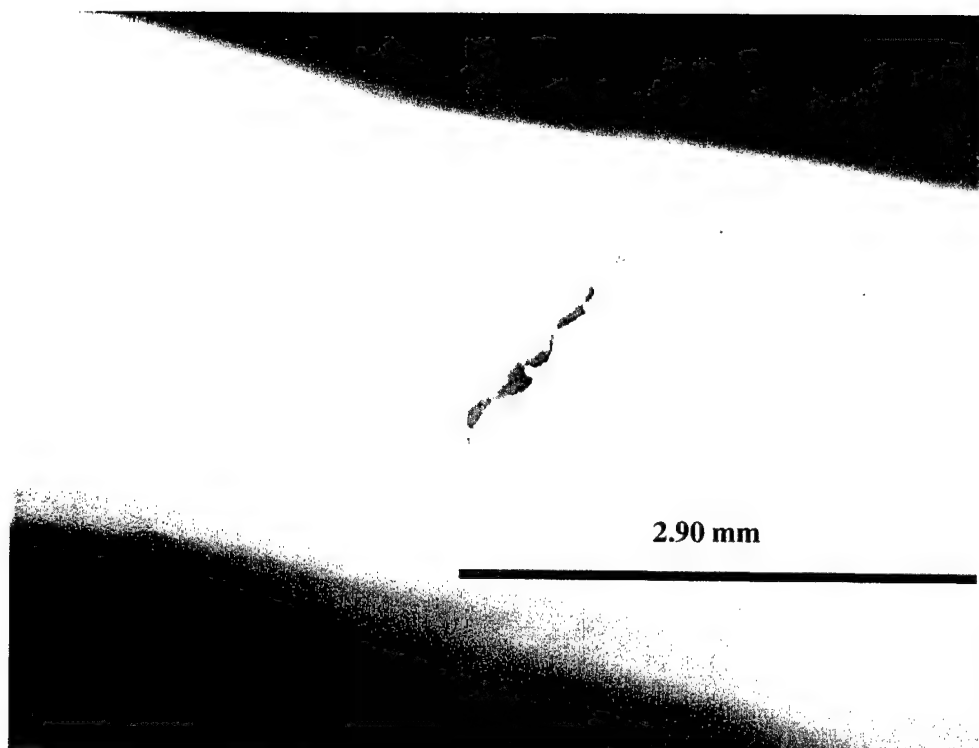
Figure 3. Typical damage caused by tying the cable wire to the bend test fixture. This cable had been soaked in Cryotech.

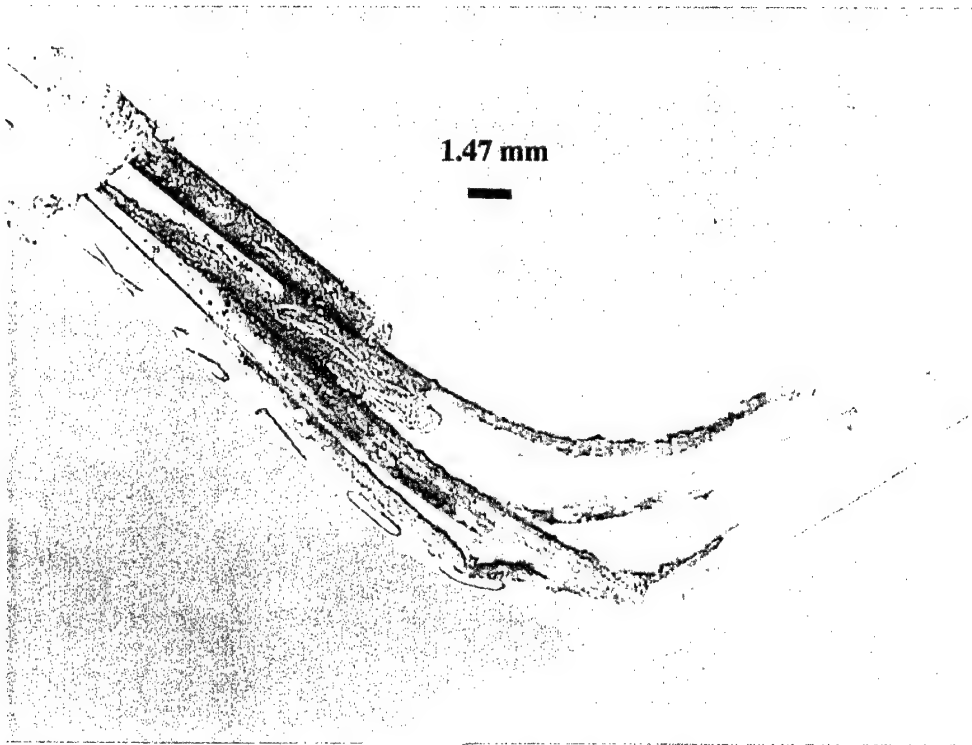
Figure 7. Example of polyimide insulated wiring which underwent
wet arc track resistance testing (#14) with sodium formate
deicing solution and 0.5 ohm resistance. This specimen went 4.9
hours until failure. Three wires failed and the maximum damage
length was 0.863 inch. If the wires had remained horizontal, the
time to failure would have been shorter.

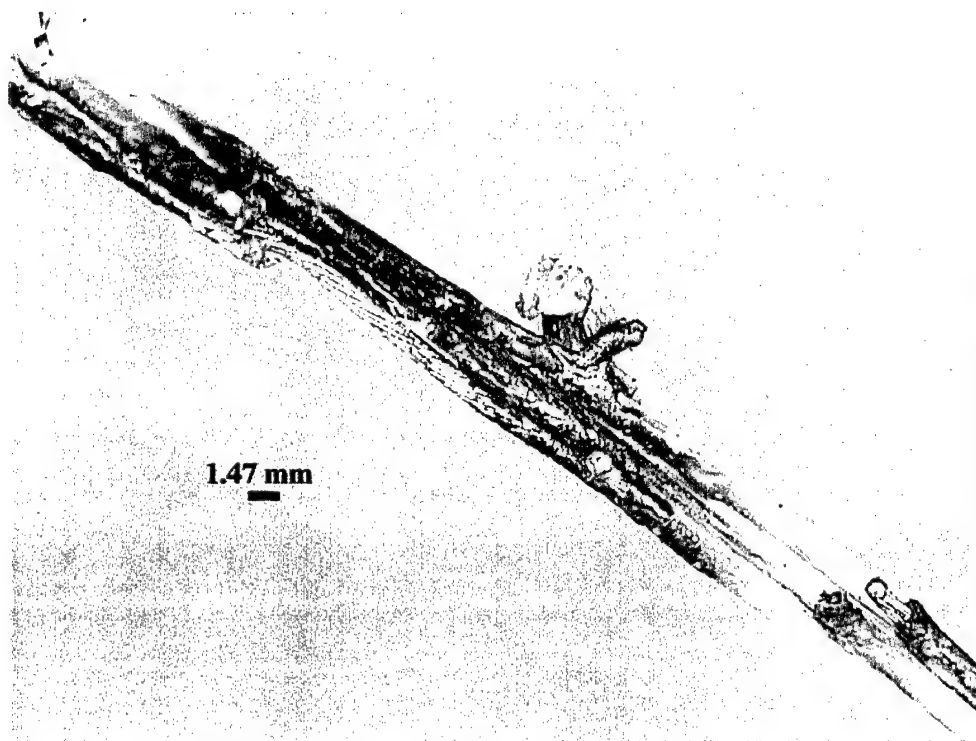
Figure 8. Example of polyimide insulated wiring which underwent wet arc track resistance testing (#26) with sodium formate deicing solution and 2.0 ohms resistance. This specimen went 48.9 seconds until failure. Two wires passed and the maximum damage length was 1.61 inches.

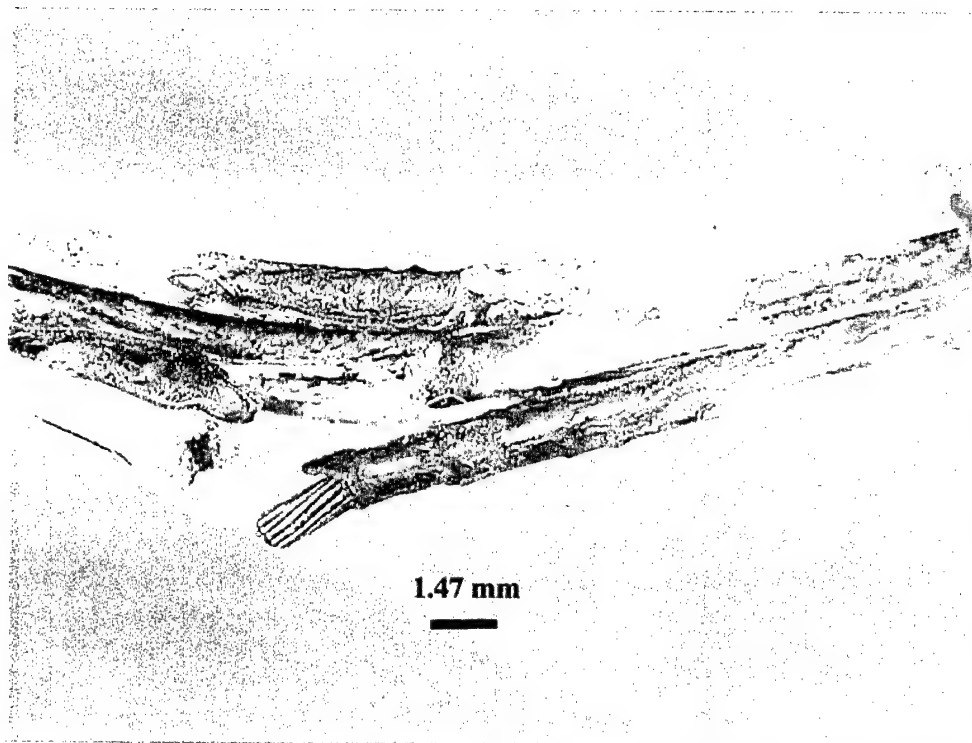
Figure 9. Example of polyimide insulated wiring which underwent wet arc track resistance testing (#3) with Cryotech deicing solution and 0.5 ohm resistance. This specimen went three minutes until failure. Five wires passed and the maximum damage length was 0.613 inch.

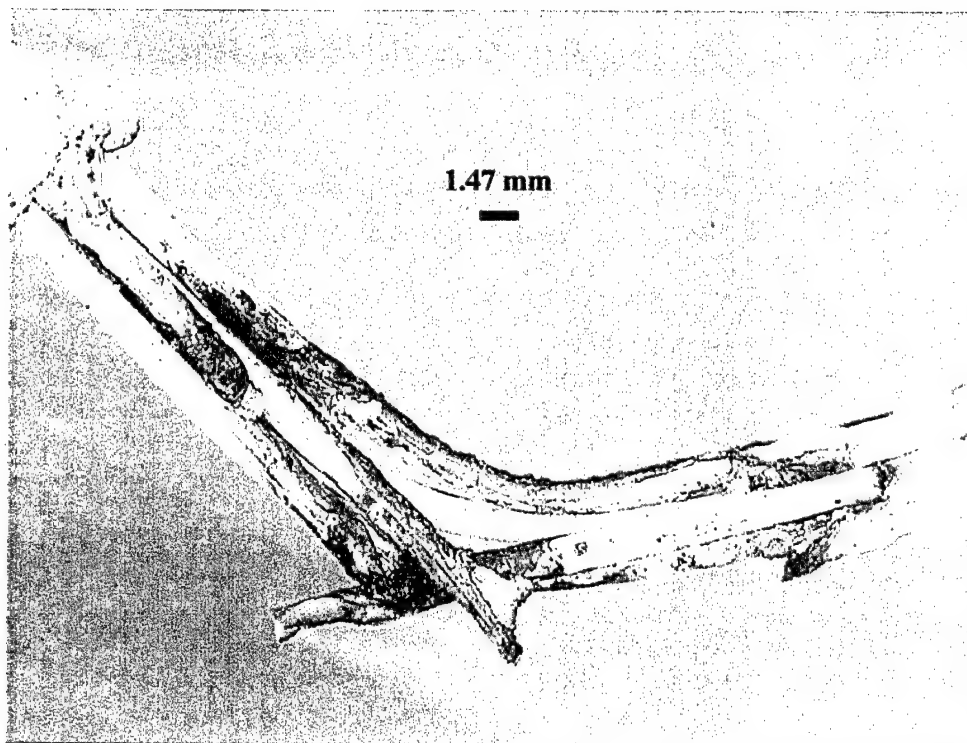
Figure 11. Example of polyimide insulated wiring which underwent wet arc track resistance testing (#11) with octagon deicing solution and 0.5 ohm resistance. This specimen went 20 seconds until failure. Three wires passed and the maximum damage length was 0.560 inch.

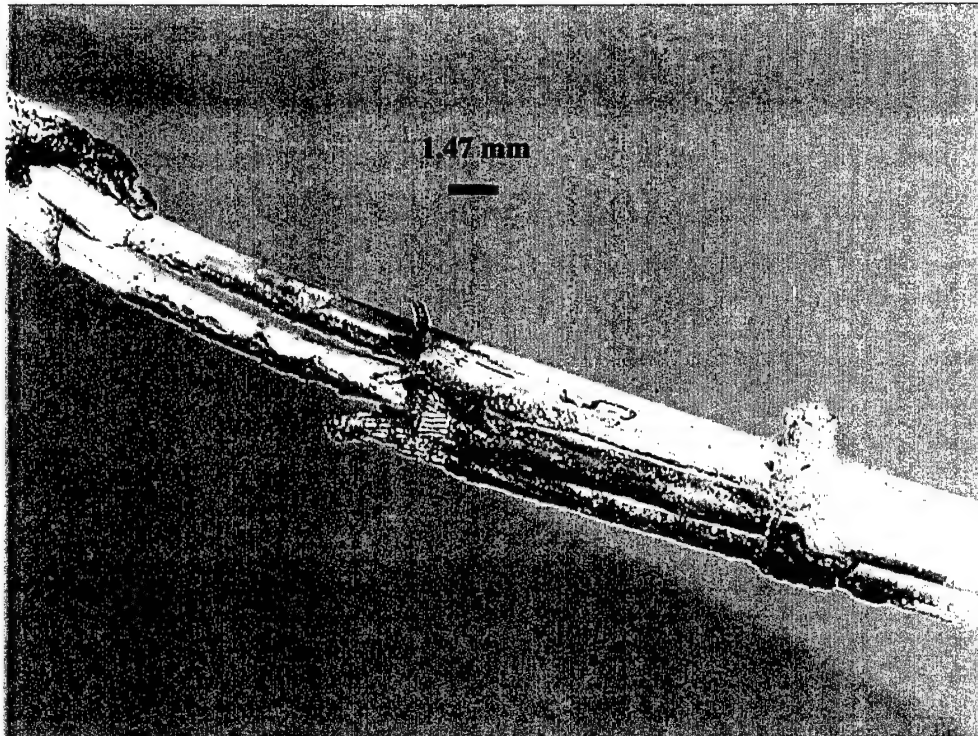
Figure 12.   Example of polyimide insulated wiring which underwent
wet arc track resistance testing (#17) with octagon deicing
solution and 2.0 ohms resistance.   This specimen went two minutes
until failure.   Two wires passed and the maximum damage length
was 1.396 inches.

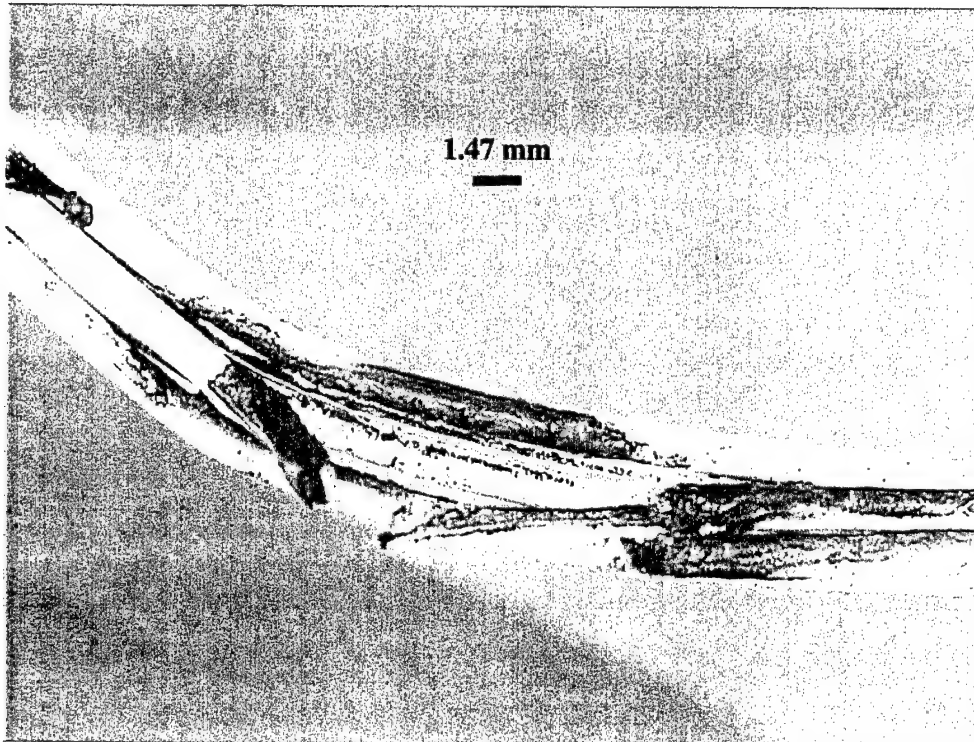
Figure 13. Example of polyimide insulated wiring which underwent wet arc track resistance testing (#6) with UCAR deicing solution and 0.5 ohm resistance. This specimen went 45.3 minutes to failure. Three of the wires passed and the maximum damage length was 0.795 inch.

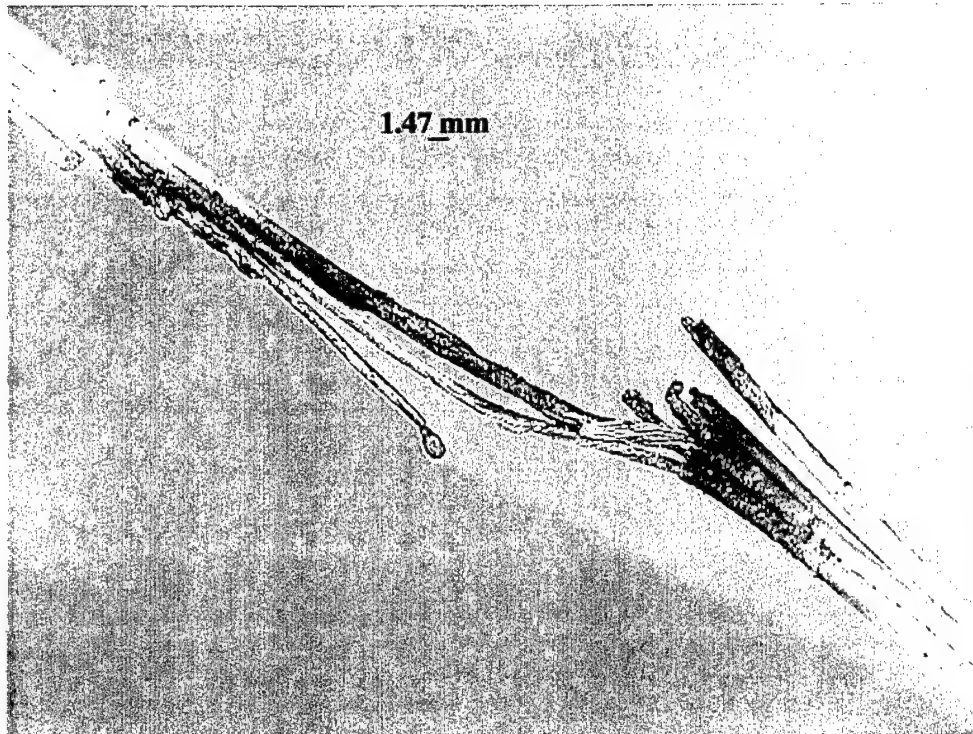
Figure 14.   Example of polyimide insulated wiring which underwent wet arc track resistance testing (#22) with UCAR deicing solution and 2.0 ohms resistance. This specimen went four hours until failure. All of the wires failed and the maximum damage length was 2.67 inches.
